TECHNICAL REPORT

AIRBAG ACCIDENT INVESTIGATION

CASE NO. 92-03

COUNTY, FLORIDA

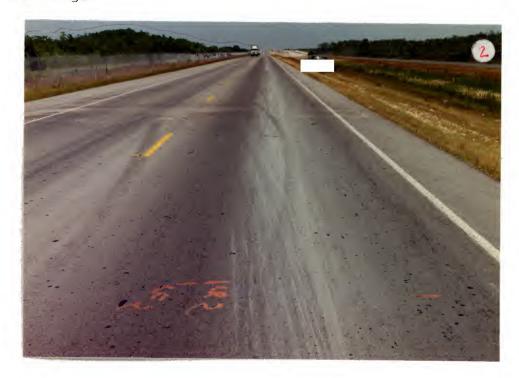
- View of the area of impact.
- 4. View of the gouges at the point of impact.

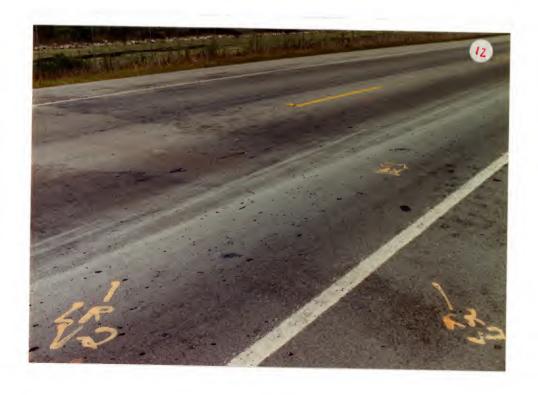
clockwise. The counter right front corner was the initial point of impact direct with damage extending 48 in. (121.9)the front cm) across The bumper. entire frontal plane sustained induced damage. Crush measurements taken across the front bumper were follows:

exterior Damaged included the components entire front both cap, right side doors, roof. left front door and the trunk lid. The vehicle was a total loss.

- 13. Frontal view of the Airbag Vehicle showing damage.
- 14. Front right view of the LeBaron.

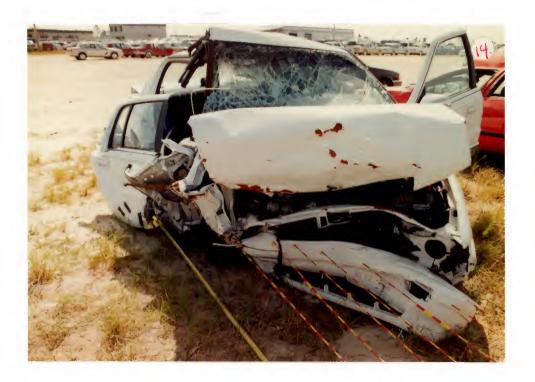
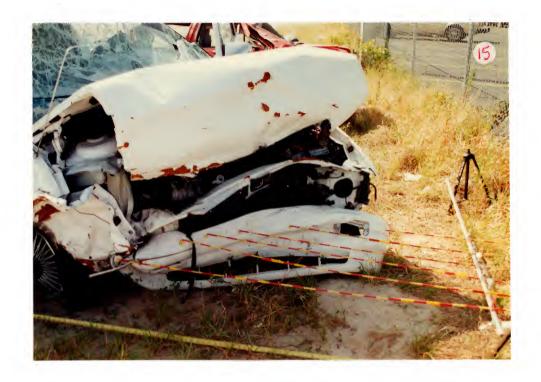
Direct damage to the LeBaron extended 48 inches across the front bumper measured from the front right corner. Maximum crush was located at the front right corner and was measured as 62 inches. A Collision Deformation Classification of 12-FDEW-6 was assigned to this impact damage. A CRASH 3 computer model resulted in a total Delta V of 43.3 mph. Damage measurements for Vehicle 2 were estimated from photographs and police markings. Direct damage of 48 inches was estimated across the front bumper measured from the front right corner. Maximum crush was estimated as 52.5 inches at the front right corner. A CDC of 12-FDEW-6 was assigned to the damage and a Delta V of 51.2 mph was generated by CRASH 3.

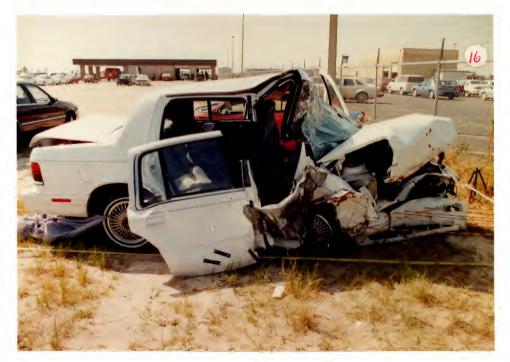
- 15. Right front view showing the crush to V1.
- 16. Right side view of V1.

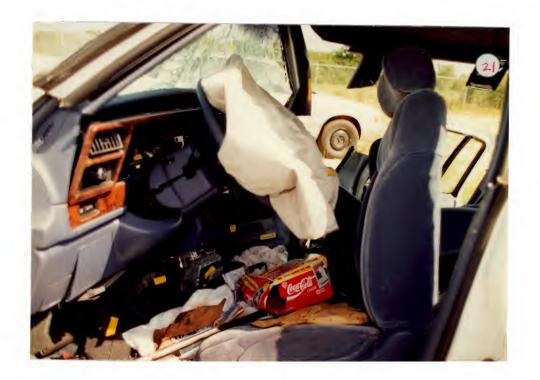
Severe damage resulted from interior compartment intrusion. occupant contact and the airbag deployment. The greatest area of intrusion was the right side floor board. Intrusion was measured at 29 in. (73.66 Intrusion to A-pillar upper was measured at 14 in. (35.6)cm) the right as was instrument panel. Inthe left trusion to side the interior compartment was measured at 4 in. (10.2 cm) to the floor and (7.6)cm) to the in. steering assembly.

- 21. Interior view showing the deployed airbag module.
- 22. Interior view showing occupant contact points.

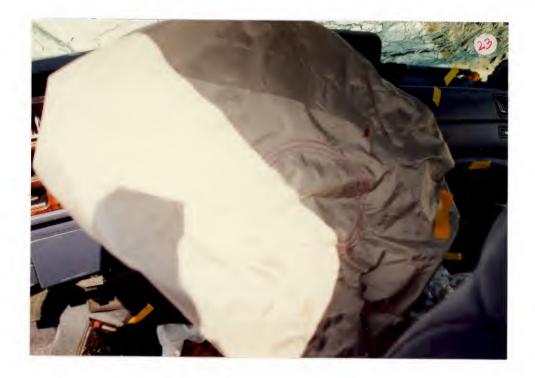
- 23. View of the deployed airbag.
- 24. Additional view of the deployed airbag.

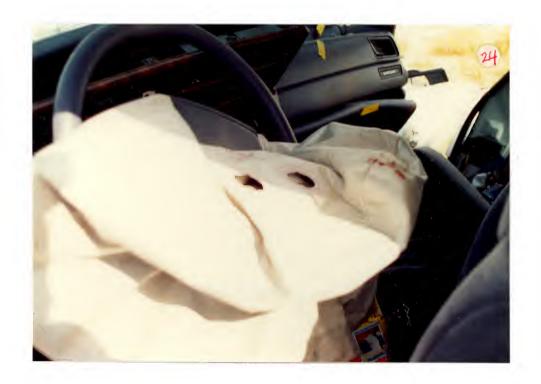
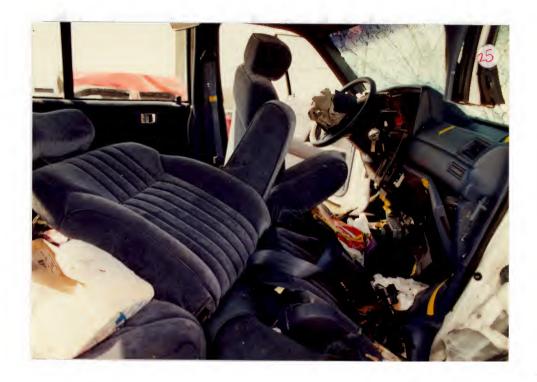
- 25. Interior view showing intrusion and occupant contacts.
- 26. Additional view of the interior of the airbag vehicle.

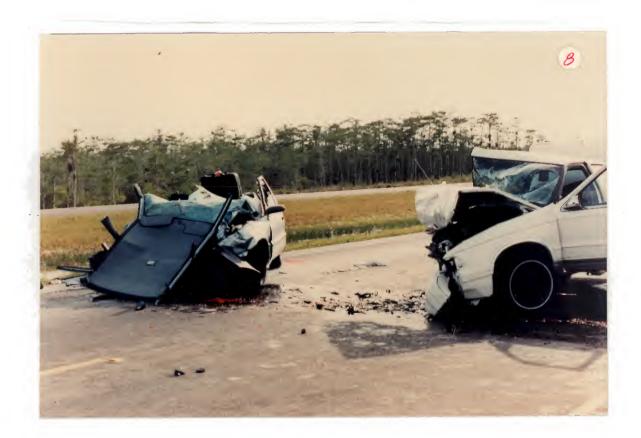
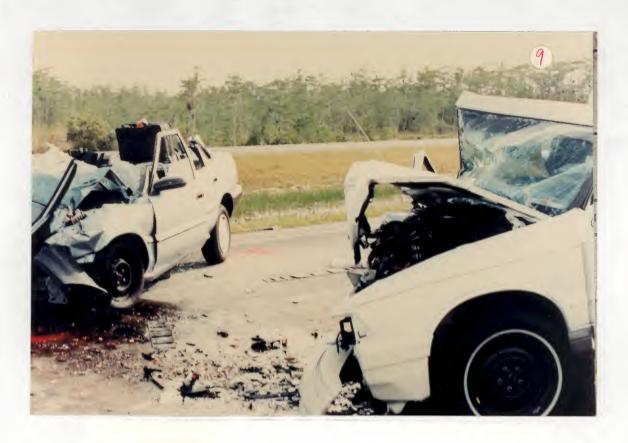
- 9. Close-up view of the vehicles.
- 10. View showing the damage to V2.

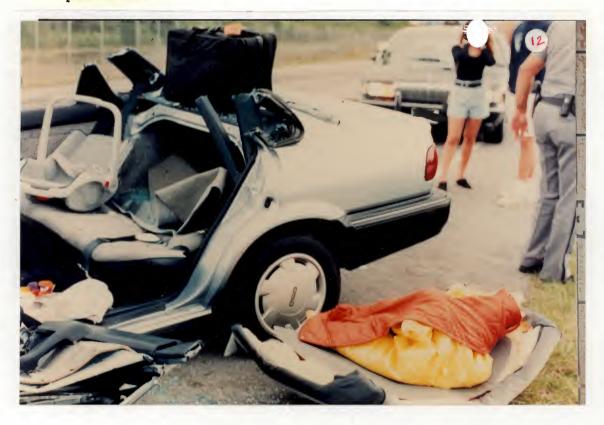
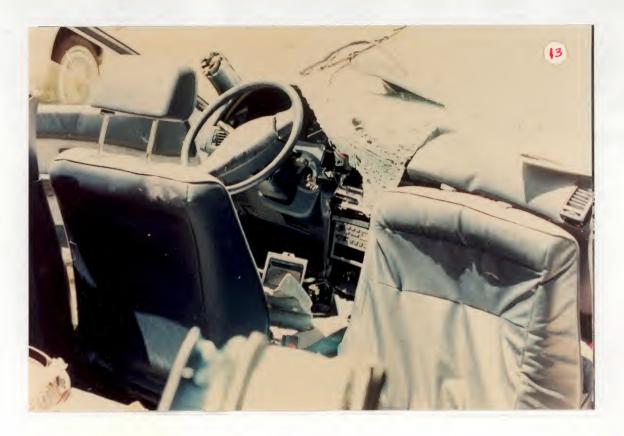
- 11. Close-up view of V2 at its final rest position.
- 12. Additional view of V2. Note the roof was cut by rescue personnel.

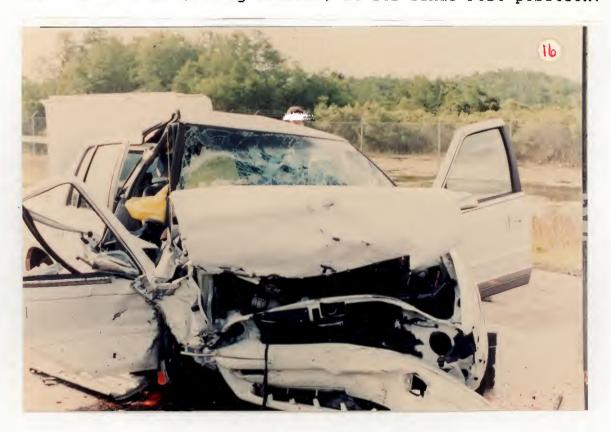
17. View of the damage to the front of V1.

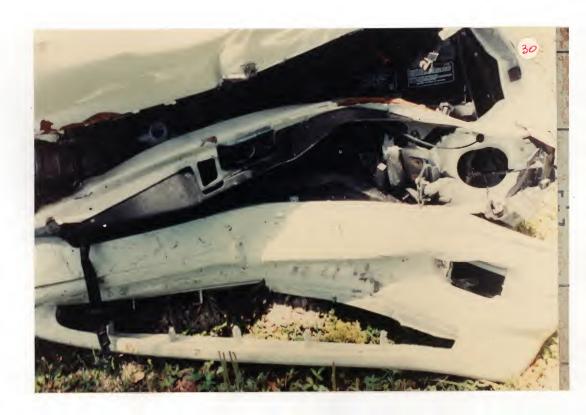
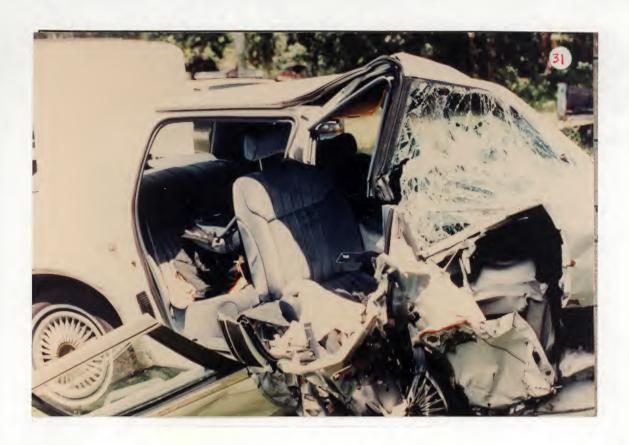
- 29. Frontal view of the Airbag Vehicle.
- 30. Close-up view of the front bumper of V1.

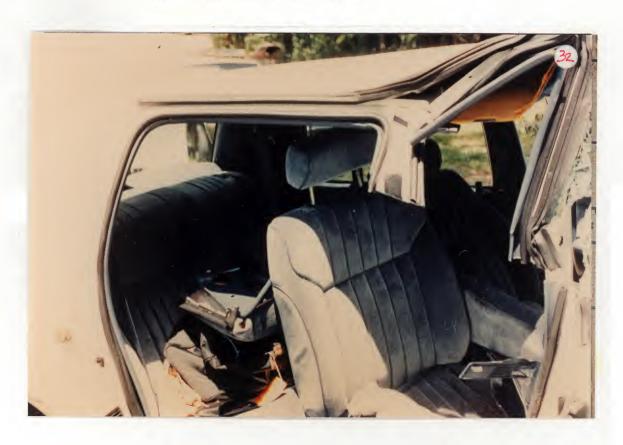
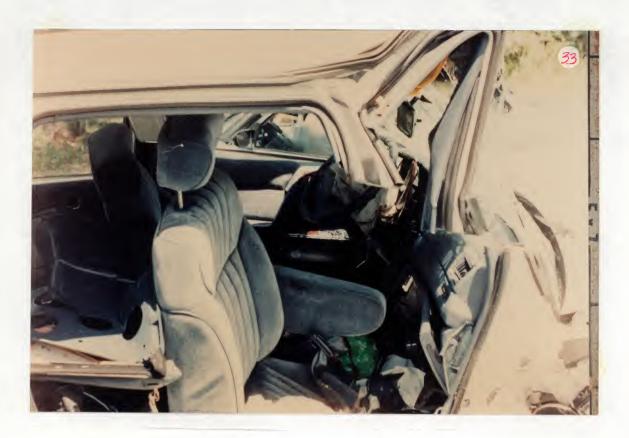
- 33. Interior view of V1.
- 34. Interior view showing the deployed airbag module.

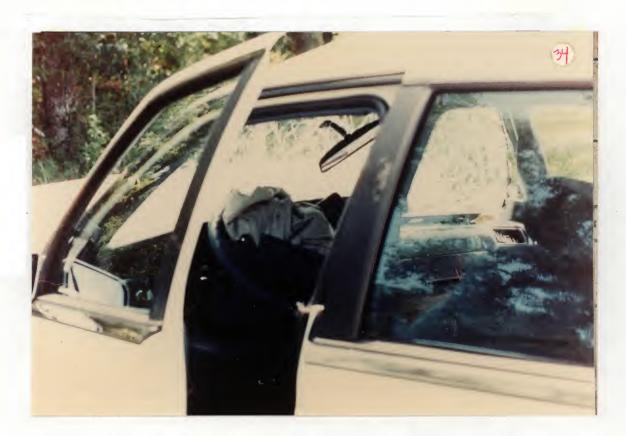
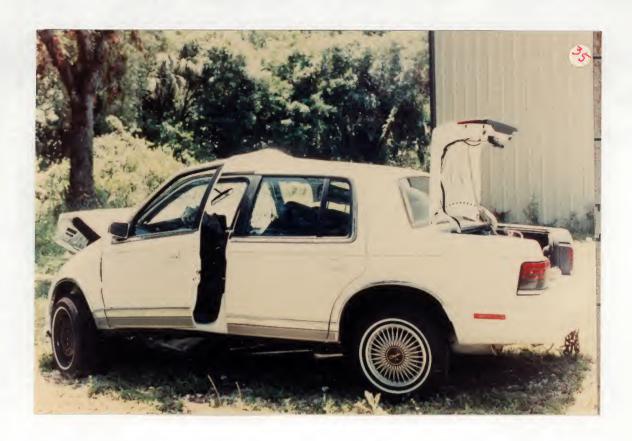
- 35. Left side view of V1.
- 36. Frontal view of V2.
